TUNNEL INSPECTION REPORT

ST. ELIZABETHS HOSPITAL – WEST CAMPUS
WASHINGTON, D.C.

Report Prepared by:
Burgess & Niple, Inc.
4160 Pleasant Valley Road
Chantilly, VA 20151

Date: February 2006

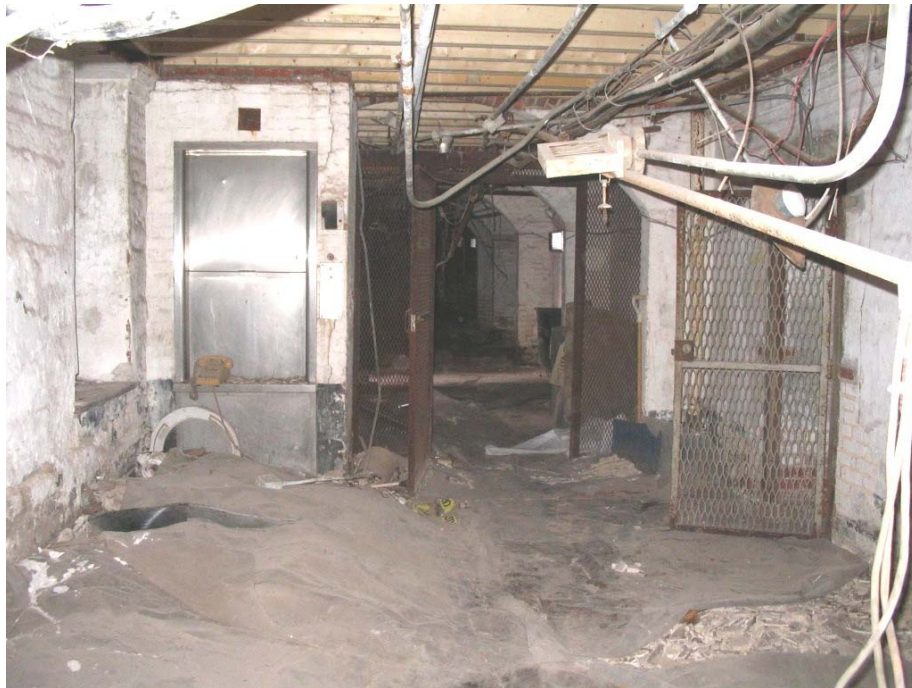
59.1	Several minor vertical cracks on walls. Sections of timber flooring above have been replaced while other sections remain in a deteriorated state.
59.6	Moderate to heavy debris scattered throughout areas.
402.1,2,3,6	Moderate to heavy corrosion on utility pipes and conduits. Some sections of pipes, conduits, and wiring are sagging and hanging from ceiling.

Photo 4: Looking west; Note hanging conduits and wires

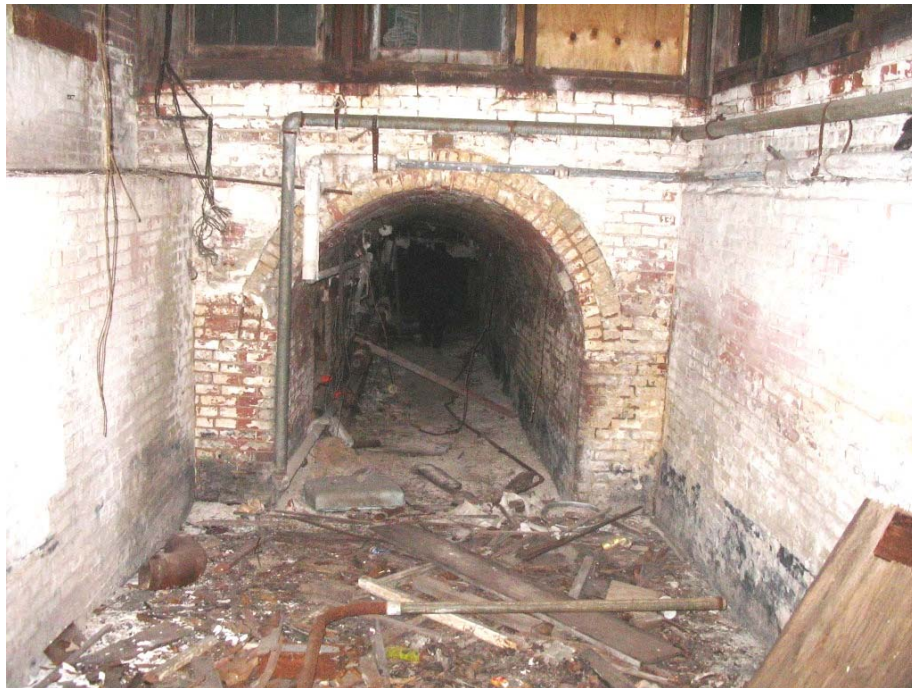
Photo 8: East portal of arch portion at west end of tunnel; Note heavy debris on floor

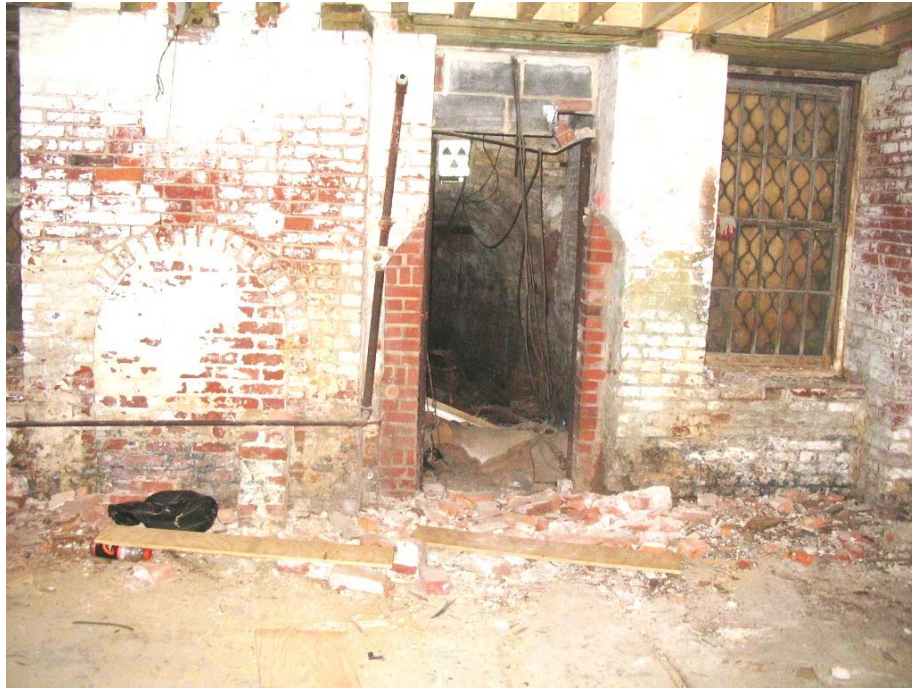
Photo 1: North portal

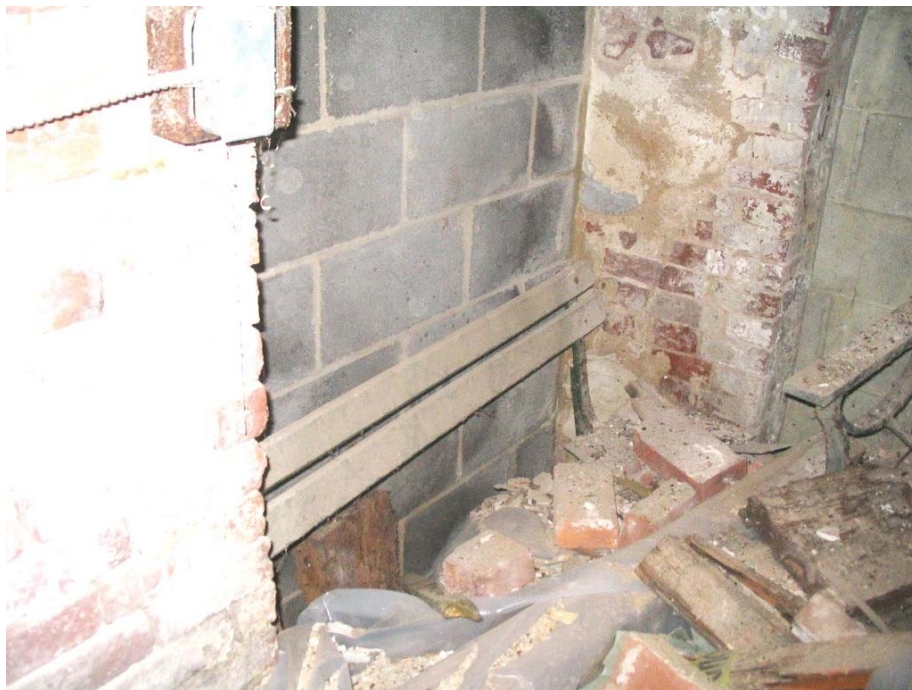
Photo 2: West portal, east side

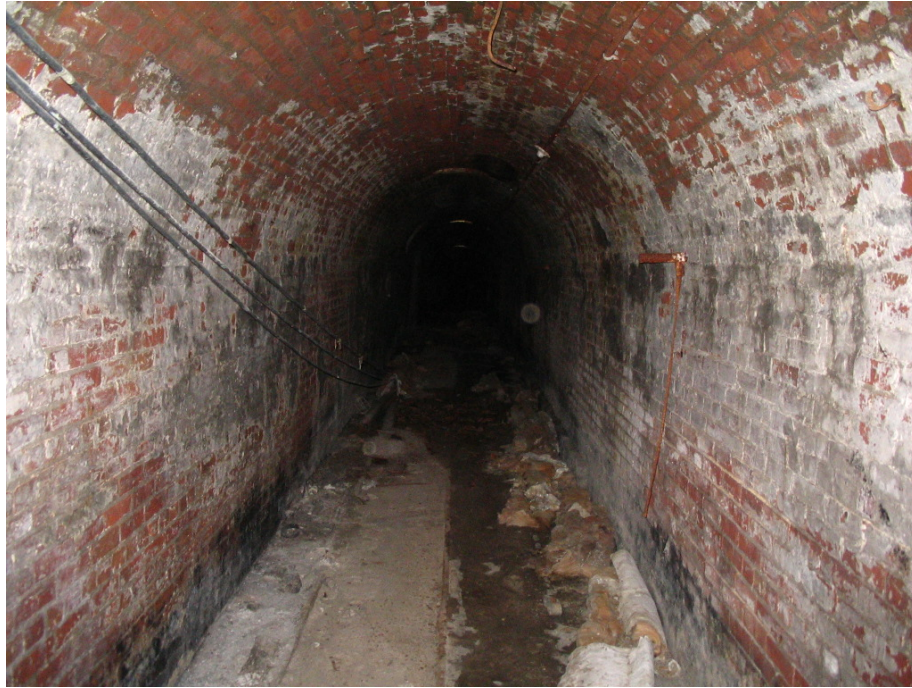
Photo 3: General view looking north from Building 34; Note downed electric lines

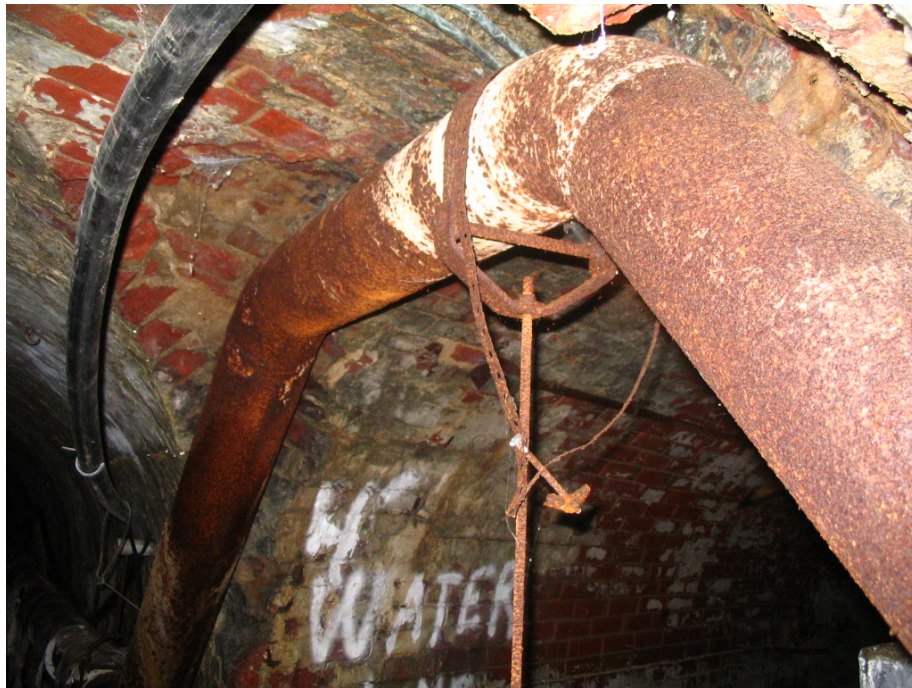
Photo 18: Steam pipe over north portal

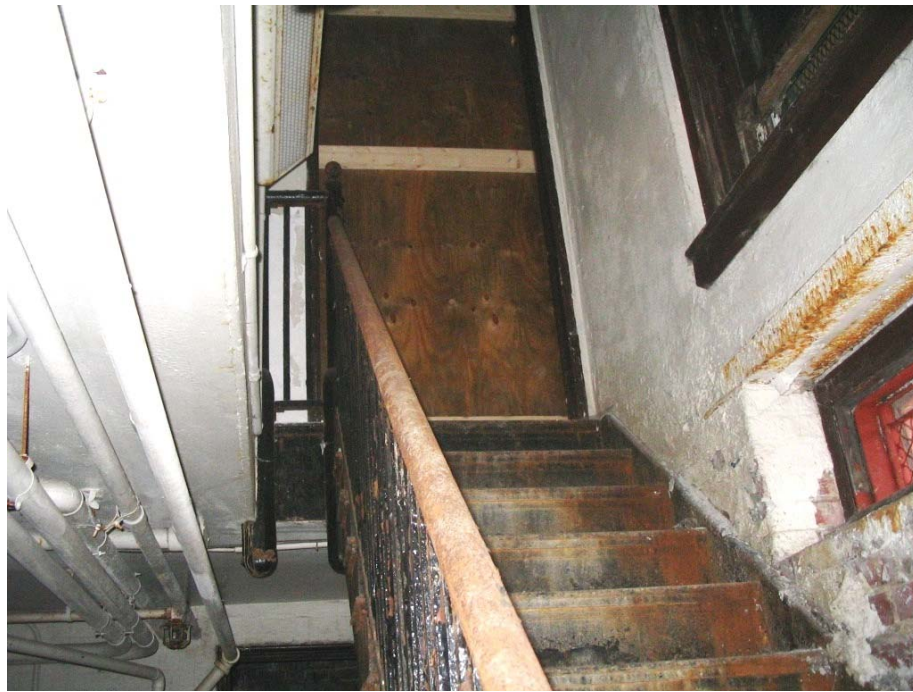
Photo 3: Sealed access doorway at stairway into Building 72

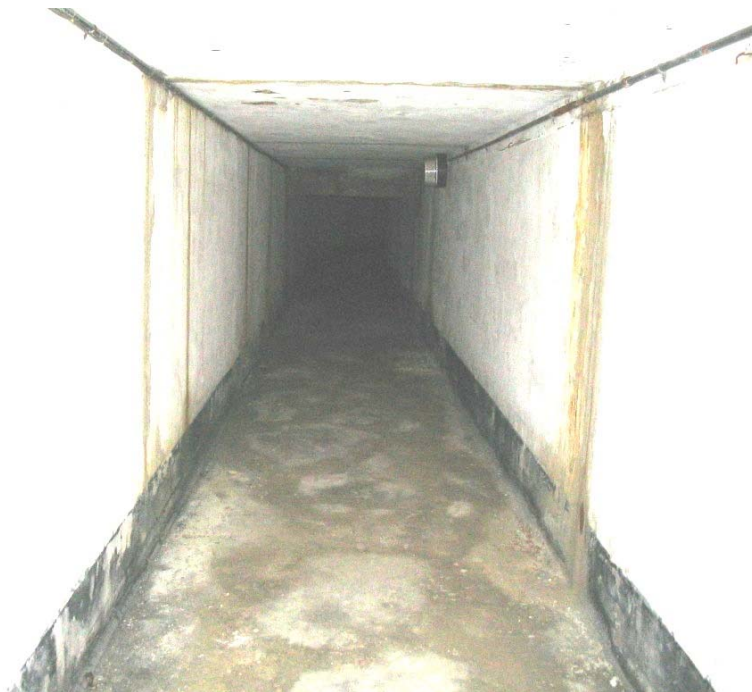
59.1	Minor vertical cracks on walls and transverse cracks on ceiling.
59.3	Undermined area of floor near north end.
402.1,2	Moderate rust on pipes.
402.3	Total section loss on conduit at kink in tunnel (about 140 ft from south end). Minor corrosion along conduits. Old conduits with exposed open junction boxes exist in wall.
402.6	Phone wires are cut.

Photo 4: Vertical Cracking on walls and transverse cracking on ceiling
